A WATERFALL OF A STRANGE NEW KIND

Restoration Options

for Richard Huws' Listed
Piazza Fountain, Drury Lane, Liverpool

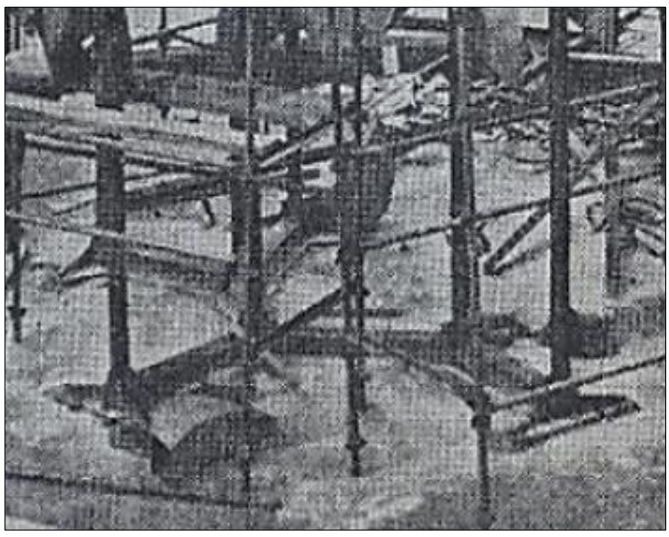
A 1967 newspaper photograph[4] showing the installation of the hoppers, reveals the flanged, probably mild steel[5], base frame of the fountain, comprising a manifold with pipes connecting the bases of each of the 7 vertical supply pipes *(Figure 1.1)*. It is clear that Richard Huws had no intention of this base frame being seen, having a pool depth of over 16 inches and creating waves and white water in the pool through which the 7 vertical supports of the fountain simply emerged *(Figure 1.2)*.

Figure 1.1: **Base frame/manifold of fountain, 1967**

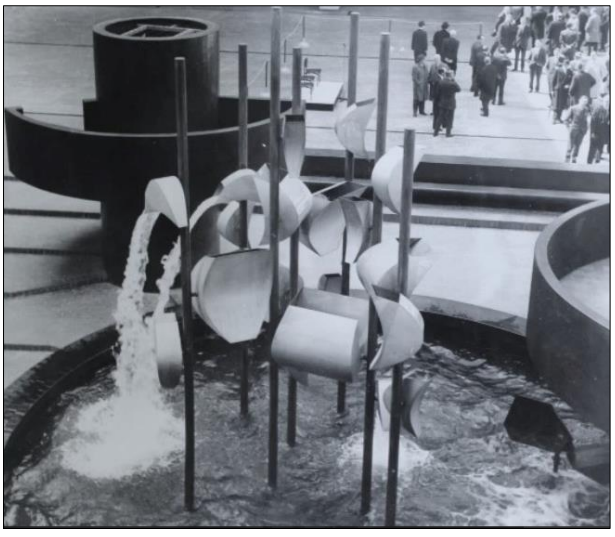
Figure 1.2**: Fountain on opening day – May 1967**

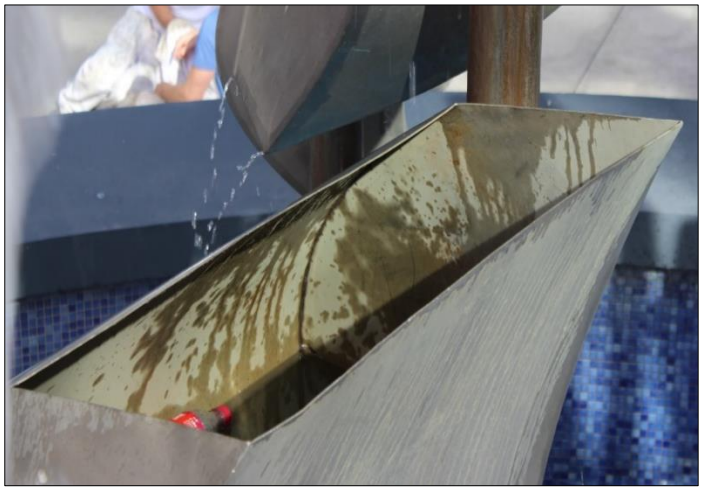
Being manufactured from good quality stainless steel[12] and having a Tufnol laminated resin based sleeve the overall condition of the 20 revolving hoppers remains very good. However, some hoppers, particularly the larger ones around the once purely rectangular 'mouth', have become bent and distorted *(Figure 2.1)*. Their surface is also now dull and often stained, compared to their original pristine and shiny condition *(Figure 2.2).*

Figure 2.1: **Bent, distorted and stained hopper**

A well as dealing with the leakage problems, therefore, all such hoppers need carefully restoring to their original shape. As recommended by IHC's restoration report[13], they also all require a thorough clean and polishing, possibly using acetone as originally used to clean the hoppers in 1967 by Cammell Laird, prior to their initial assembly[14].

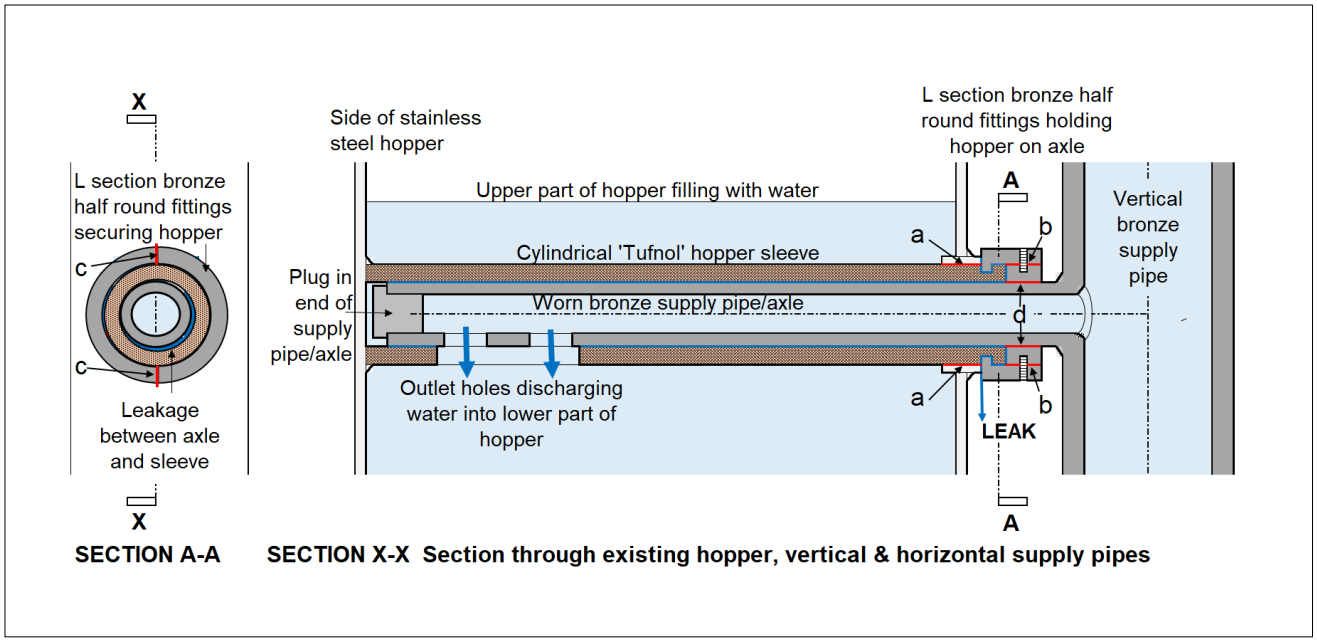
Figure 3.1: **Sections through hopper bearings showing possible leakage points**

As well as the main leakage between the worn bronze axle and Tufnol sleeve, the smaller hoppers may also now be leaking at other points *(as shown in red on Figure 3.1 and in the last photograph in Figure 3.2),* that is possibly:-

a) between the stainless-steel ring welded into the side of the revolving hopper and the similarly revolving projecting 'Tufnol' sleeve.
b) between the removeable bronze half round fixings and the fixed bronze ring to which they are screwed.
c) between where the two half round fittings butt together when screwed in place, and/or
d) between the bronze ring and the bronze axle/supply pipe to which they are fixed.

Firstly, any additional leakage at points (a), (b), (c) and (d) above, where there is no differential movement between the components, needs to be fully sealed, for example, by re-welding, gluing or with the installation of a thin neoprene gasket between the components.

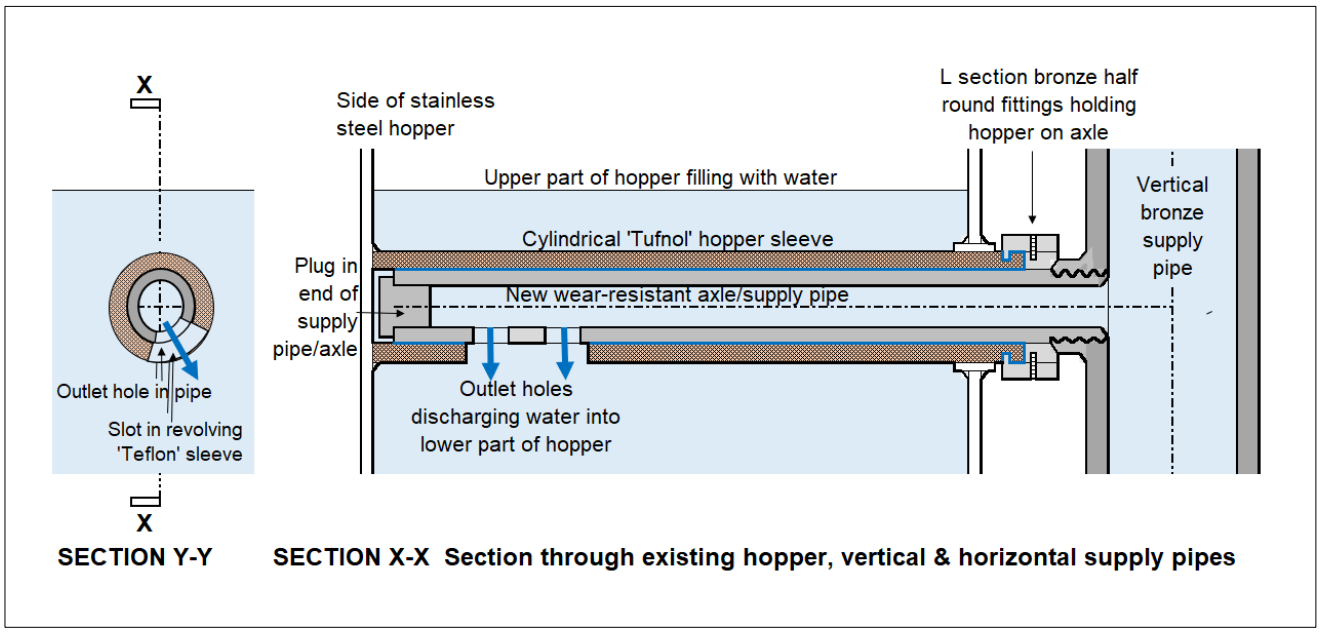
Figure 3.3: **New wear-resistant axle/supply pipe screwed to existing vertical**

The escape route for the water (*as shown by the blue line above*) is already fairly long and tortuous, after all other possible leakage points have been sealed. Consequently, greasing the axles and the projecting Tufnol sleeve with one of the thicker varieties of waterproof marine grade grease[20], designed to provide a water barrier and prevent washout, should go a long way to minimising the main leakage. Removing the securing half-round fittings

The aim of replacing the bronze axles would be to restore the gap between the axle and the surrounding Tufnol sleeve to a minimum commensurate with the hoppers freely revolving. The new axles could either be re-welded to the existing verticals or, as proposed by the IHC report[19], screwed to the verticals to allow for their occasional removal to facilitate maintenance *(Figure 3.3)*.

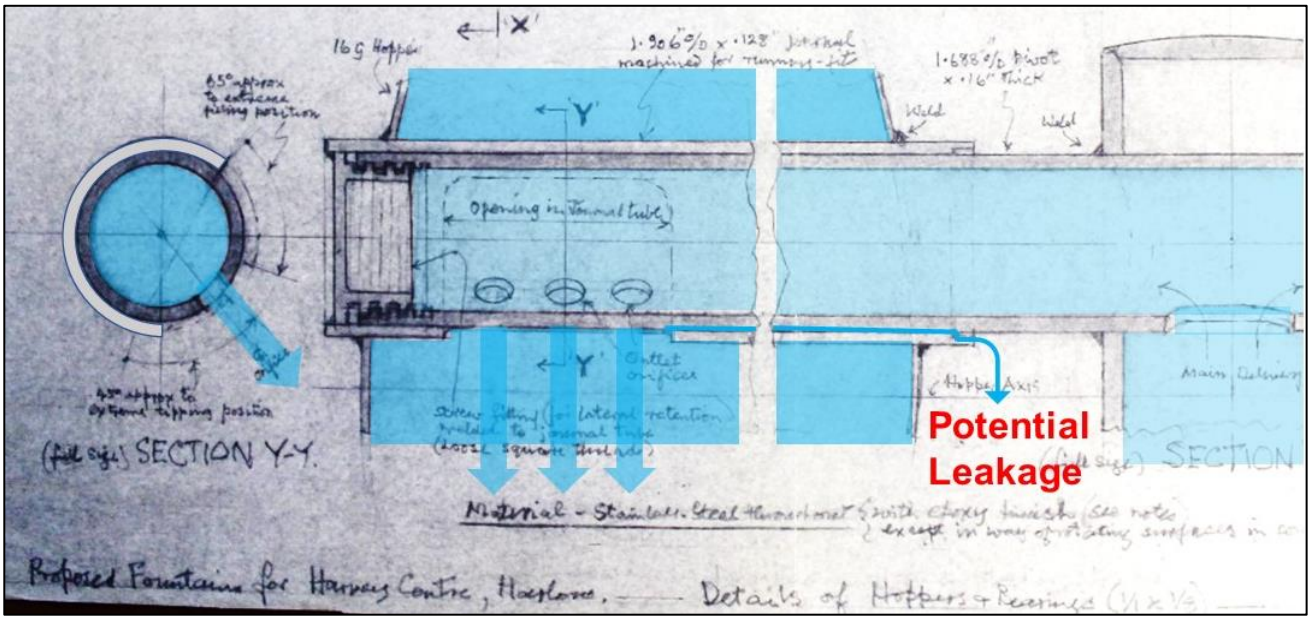
In early 1979, Richard Huws' had suggested an ingenious solution to the leakage problem for the cantilevered hoppers in his proposed fountain for the Harvey Centre, Harlow.[23] Although never built, this was his seventh and final commissioned project to use tipping hoppers and appears to be appropriately his most sophisticated design. As indicated by his working drawing[24] (*Figure 3.4 with the author's-coloured highlights*), he proposed welding a screw fitting to the end of the hopper sleeve which then screwed onto the end of the fixed axle/supply pipe.

As labelled on his working drawing, this screw fitting was designed to prevent any major lateral movement of the hopper but generated a very small lateral shift as the hopper swivelled through 90 degrees to re-right itself. This small shift appears to have been utilised to tighten the opposite end of the sleeve against the nib on the inner tube, to prevent any leakage at this point as the upright hopper fills, and conversely to loosen and break this seal when the hopper finally tips when full.

Figure 3.4: **RH's working drawing of hopper for fountain for the Harvey Centre, Harlow**

Albeit having a different hopper shape, the bearing comprising a sleeve revolving around a fixed axle/supply pipe was essentially the same in the Harlow design as in the previous Liverpool fountain. Thus, Richard Huws' 'screw' device could be equally applied to the renovation of the Piazza Fountain *(as illustrated in Figure 3.5).*

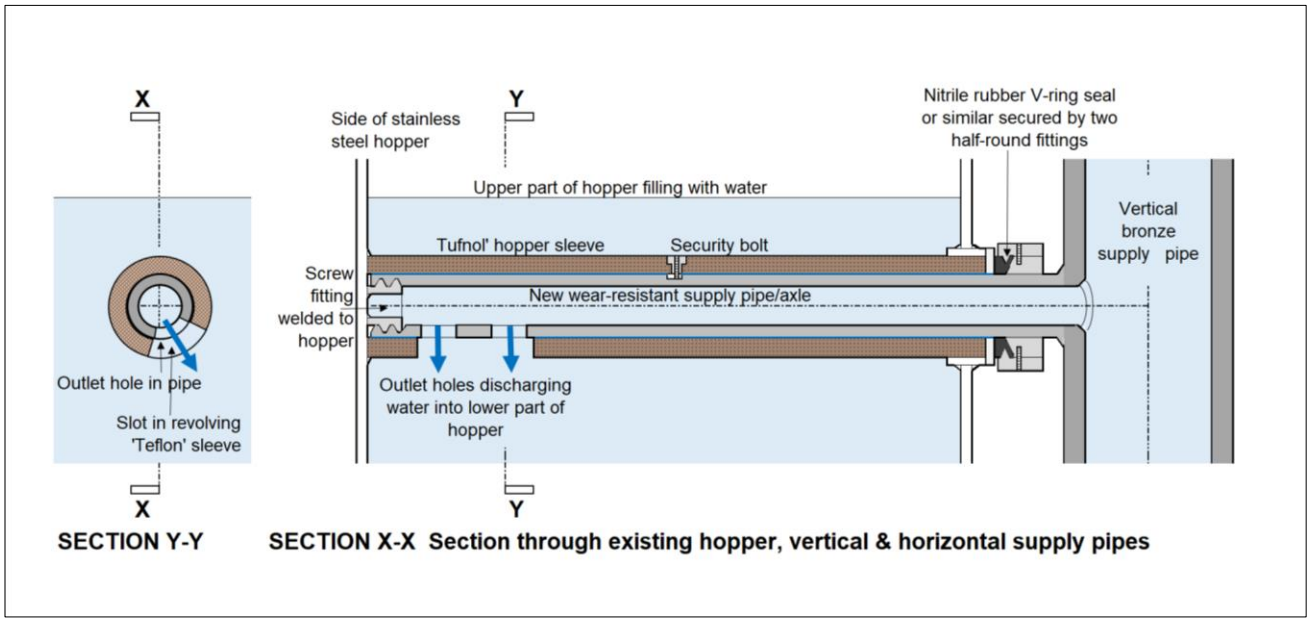
Figure 3.5: **Modification of smaller hoppers based on RH's Harlow design**

In this proposed modification, as well as welding a new screw fitting to the inside of the hopper, which would screw into the end of the new axle/supply pipe, the projecting end of the Tufnol sleeve would be replaced by a stainless-steel 'disc' welded to the other side of the hopper. This would be manufactured in 316L stainless steel, this grade being recommended by IHC for all new stainless steel parts and replacements for existing worn and corroded fixings[25].

With the hopper in the vertical position, the latter would butt up tightly to a replaceable nitrile rubber V-ring or similar circular seal held firmly in place by two half-round fittings screwed to a new ring fitting welded to the axle close to the vertical supporting supply pipe. The latter three fittings would replace the existing three bronze fittings which currently hold the smaller hoppers in place and could be of virtually identical size and external appearance.

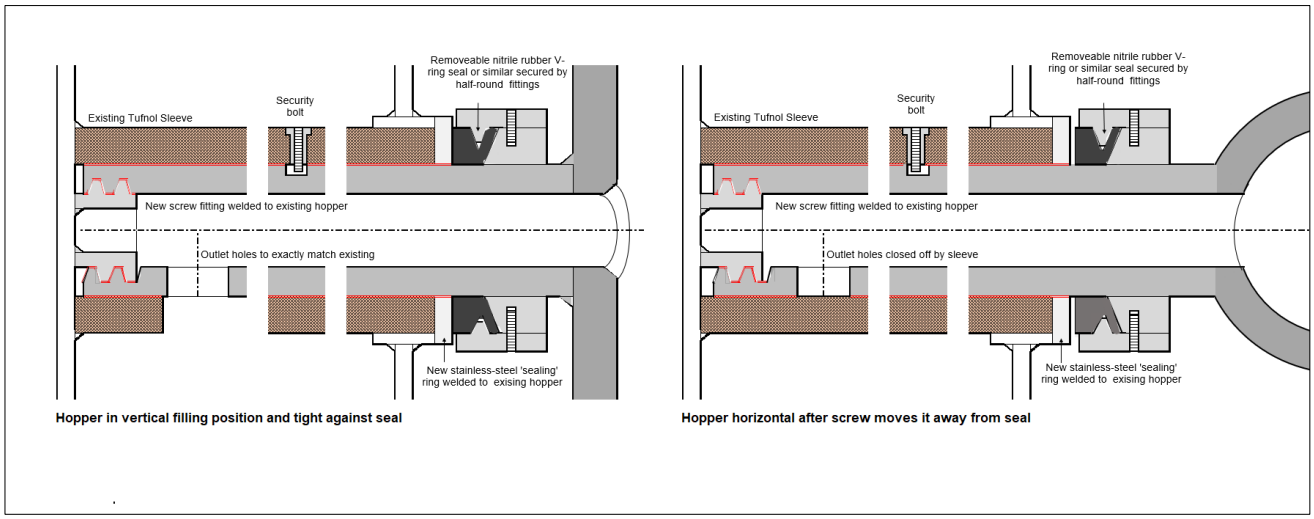
As soon as the hopper starts to tip, the seal holding back any premature leakage would be broken, as the hopper moves marginally away from the vertical due to the action of the screw fitting at the end of the axle. Conversely, as the hopper then re-rights itself, it would move marginally back along the axle to re-establish the seal while the hopper is again filling with water. *(This is illustrated in more detailed in Figure 3.6.)*

Figure 3.6: **Detailed vertical and horizontal sections showing action of screw fitting**

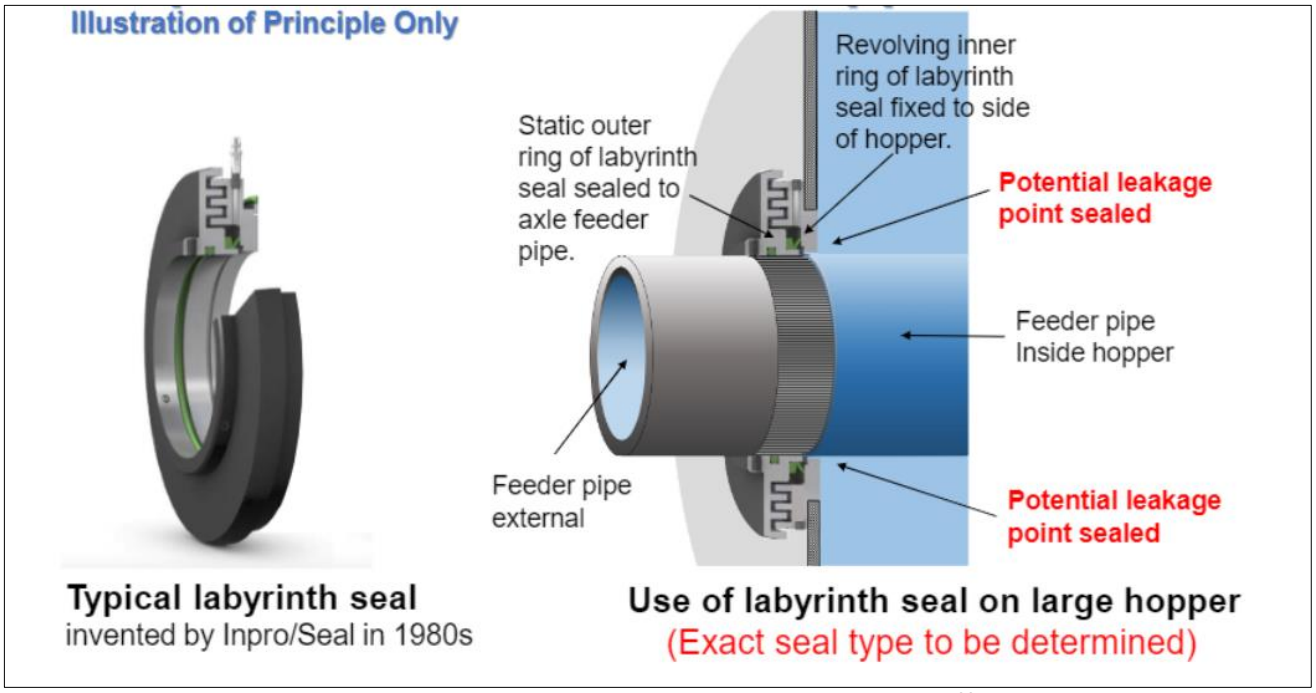
Early on in our discussions, James Mitchell, of Industrial Heritage Consulting (IHC), had suggested that to stop the leakage from the fountain, labyrinth seals might be applied.[27] He did not elaborate on what type of labyrinth seals would be appropriate at the time or subsequently in IHC's interim restoration report, but *Figure 3.7* indicates how such seals might conceivably be applied.

***Figure 3.7*: Typical labyrinth seal and its possible application to the hoppers[28]**

For the smaller hoppers with the continuous sleeves, the revolving part of the ring seal would need to be similarly welded to the side wall of the hopper nearest the vertical supply pipe, while the static part was welded to the adjacent fixed axle. The integral greasing point/nipple would allow the labyrinth and axle to be pressure injected with marine grade grease, without the need to remove the hopper. As in the previous solution, to avoid unwanted lateral movement of the hoppers and its over-rotation, a security bolt screwed through the hopper sleeve projecting into a groove running around the new fixed axle could be provided. Again this bolt would be simply unscrewed from the sleeve should the hopper need to be removed from the axle.

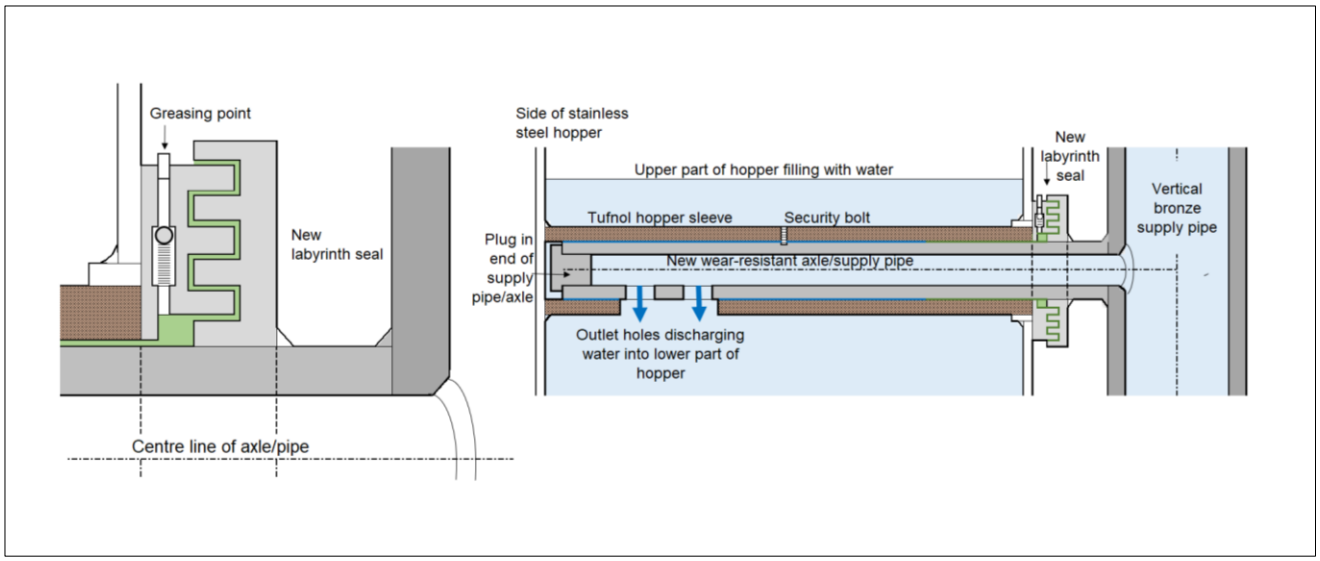
***Figure 3.8*: Possible application of a labyrinth seal to a smaller hopper.**

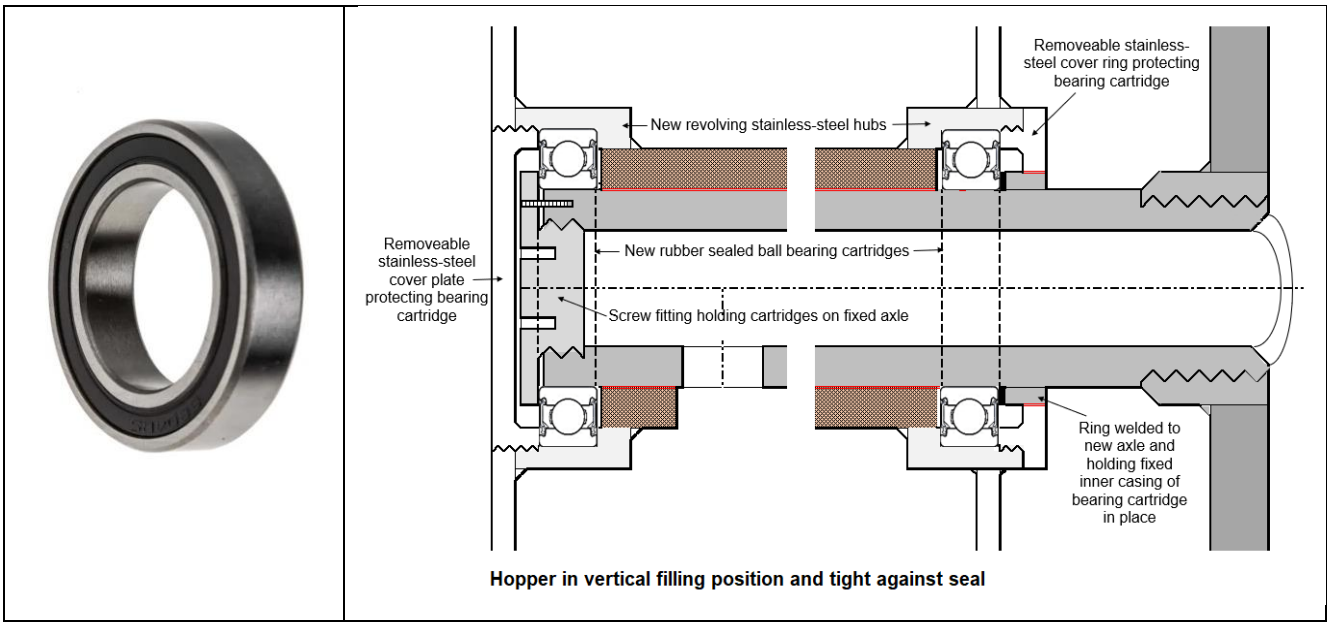
***Figure 3.9*: Typical ball bearing cartridge and possible application of these to the smaller hoppers**

The ball bearing cartridges are normally pressure fitted in place, so it is proposed that the existing rings that are welded into the sides of the hoppers be replaced with a flanged stainless-steel hub specifically designed to house these cartridges and that a similar new hub be welded to the opposite inside face of the hopper. The outer casing of the sealed cartridges is thus held firmly to the revolving hubs by pressure. The inner casing could be held on the fixed axles by a fitting that screwed into the end of the axle and pressed firmly on the inner casing of the

nearest cartridge. This screw fitting would also press the inner casing of the other cartridge on to a ring/nib welded or screwed to the other end of the axle to similarly hold this firmly in place.

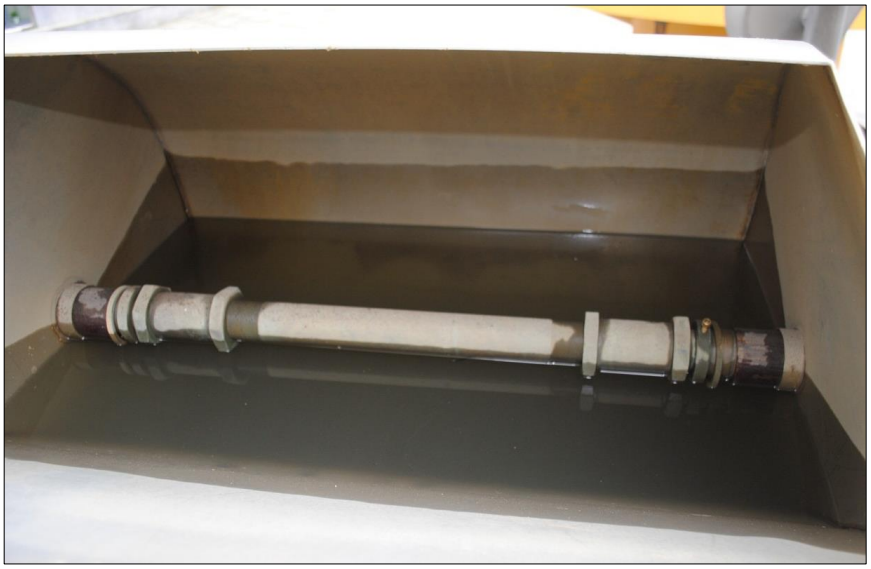
The bronze bearings of the 6 heavy larger hoppers appear to have suffered the most wear and being subject to the larger water volume and pressure, these consequently exhibit the most leakage. In contrast to the arrangement in the smaller hoppers, in the larger hoppers the bronze axle/feeder pipe surrounded by a Tufnol sleeve is now limited to where it passes through the stainless-steel ring set in each side wall of the hopper and to a short distance from each inside wall face *(as shown in the photograph at Figure 4.1*).[32] The remainder of the supply pipe in the hoppers comprises an incongruous multi-jointed galvanised steel pipe.

Figure 4.1: **Side bearings and central supply pipe in larger hoppers**

Figure 4.2**: Leaking at bearings**

The bearings of the larger hoppers, which in the case photographed above *(Figure 4.2)* has worn so badly that the hopper has dropped by some 4 to 5 mm[35], will clearly also need to be replaced. However, this would give the opportunity to change all the previously modified horizontal feeder pipes to one that would enable the larger hoppers to be occasionally removed for maintenance purposes such as re-greasing. Restoring Richard Huws' original continuous sleeve should also be possible at the same time, assuming that any future blockage of the outlet holes in the axle/supply pipe can be permanently prevented with better filters and a better sump guard.

As with the smaller hoppers, any additional leakage from the larger hoppers between components where there is no differential movement, for example, between the stainless-steel ring welded into the side of the revolving hopper and the similarly revolving, slightly projecting, short section of 'Tufnol' sleeve will first need to be sealed *(see Figures 4.1 and 4.2).*

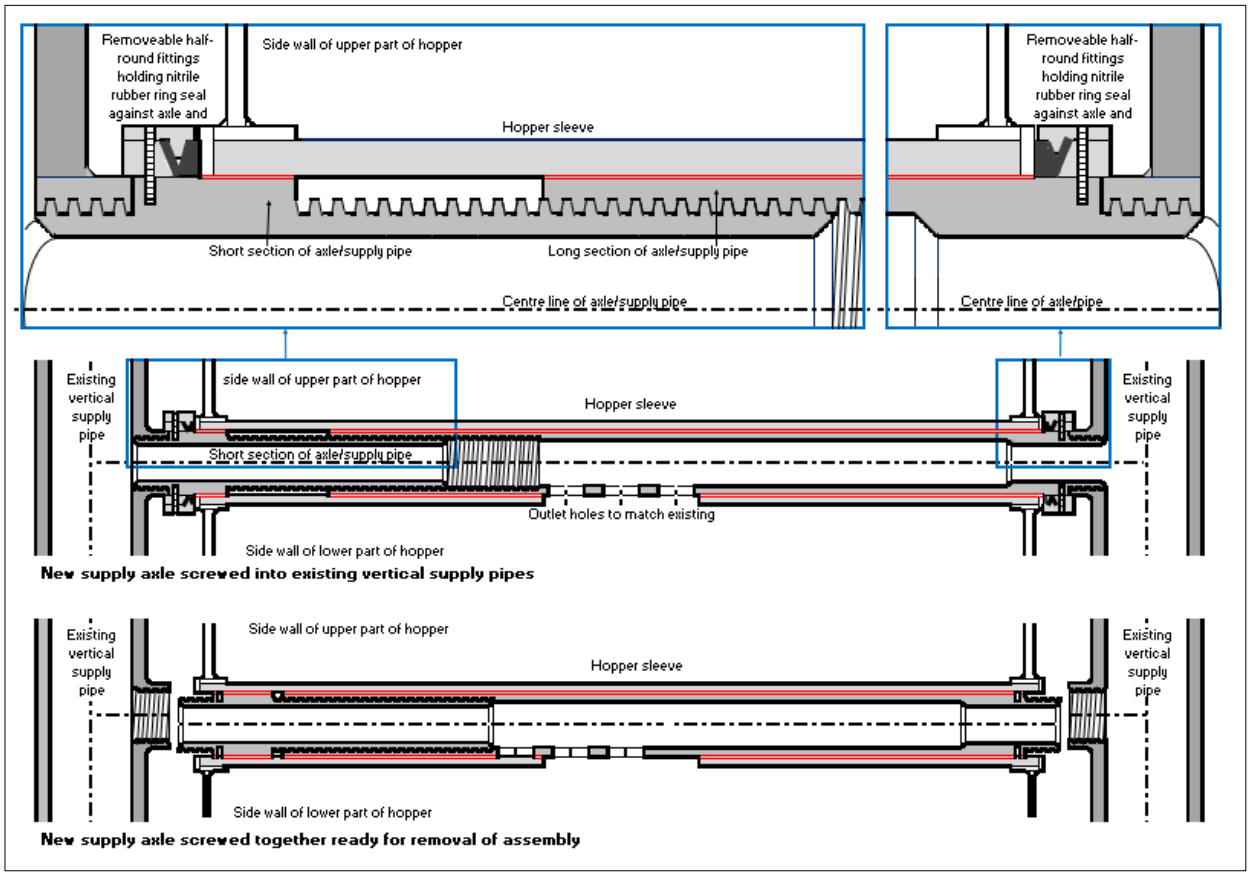
Figure 4.3: **New axle/supply pipe enabling removal of large hopper from its supports**

As suggested by IHC's restoration report[36], removal of the large hoppers could be achieved by manufacturing each new axle/supply pipe in two sections such that when fully screwed together they simultaneously unscrew from the vertical supporting pipes either side *(as illustrated in Figure 4.3*). All the half-round fittings holding the seals in place would first need to be unscrewed and removed, but the screw holes, so exposed, could then be utilised for a tool to initially loosen the axle from the two verticals into which they are tightly screwed. Once unscrewed and the hopper moved clear of the verticals supports the whole axle could then be easily withdrawn from the new continuous sleeve for re-greasing or other maintenance work.

To avoid the need of expensive cranage when removing the heavy larger hoppers, a simple rig could be devised having caps which fit over the top of the verticals supports either side, from which rope and pulleys are suspended. The latter could then be hooked around each end of the internal sleeve, to carry the weight of the large hopper while the axle is being unscrewed from the supports and then be used to lower the whole hopper assembly to the pool floor ready for the axle to be extracted.

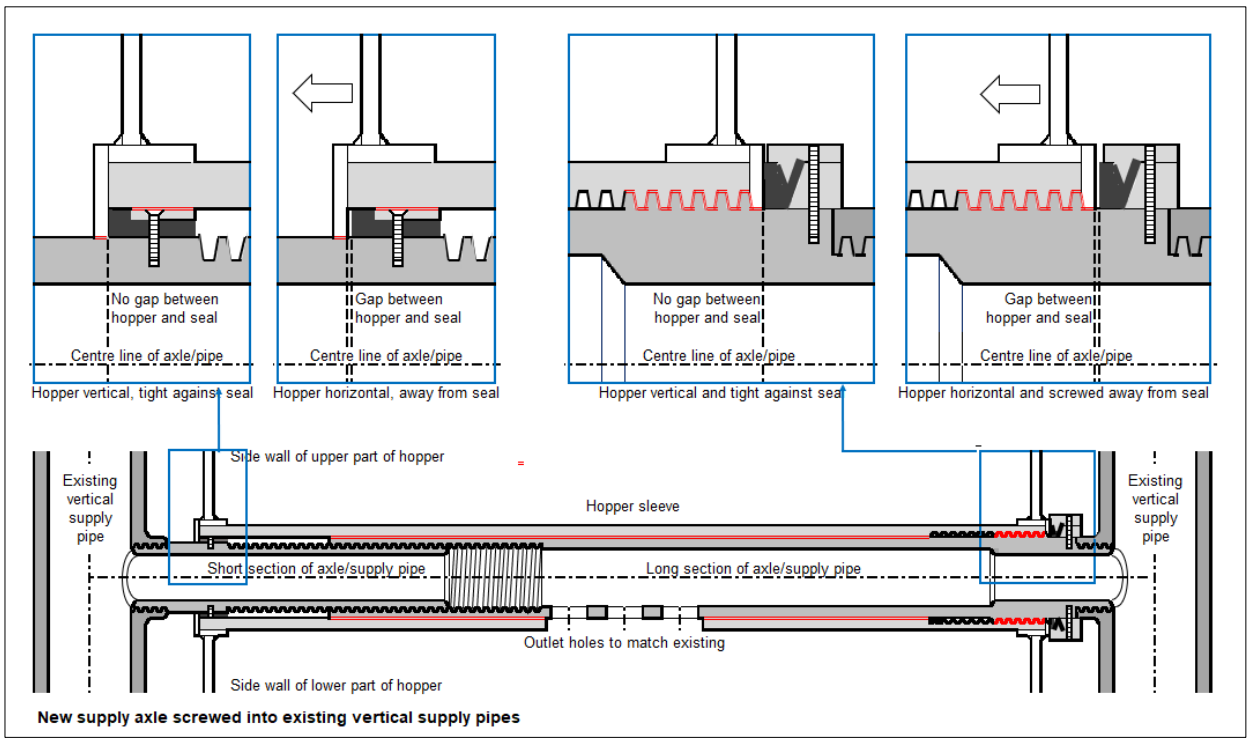
Figure 4.4: **Modification of larger hoppers based on RH's Harlow design**

Although requiring a more complex design, the new axles could also be provided with an outer screw meshing with the hopper sleeve. The screw gauge would have to be the same as used elsewhere on the axle to still enable the two parts of axle to be screwed fully and firmly together to remove it from the two verticals.

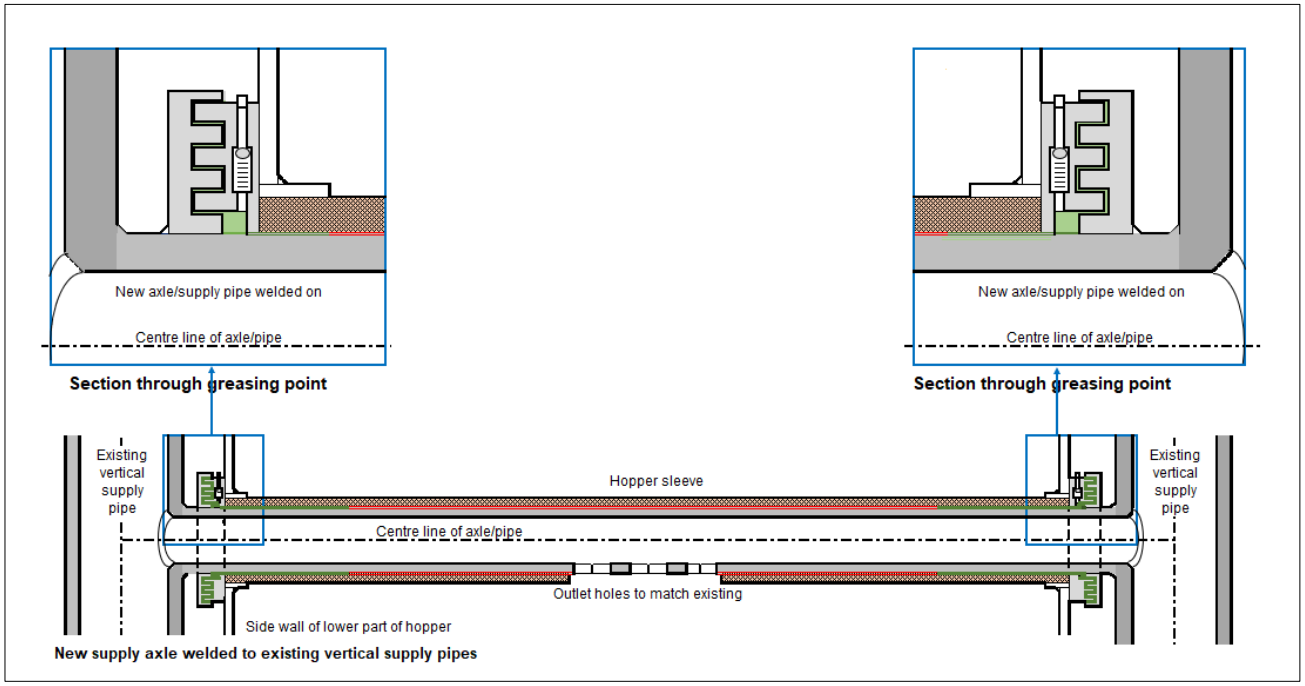
Figure 4.5: **Vertical section though new hopper axle welded to existing vertical supports**

As the labyrinth seals and adjacent axles can be injected with marine grade grease under pressure, arguably with this solution there is no need to make the larger hoppers removeable. However, this assumes that any chance of rubbish continuing to be drawn into the supply pipes can be stopped and that there would be little build-up of limescale. The existing horizontal supply pipe and bearings could, therefore, be replaced with a more straightforward tubular wear-resistant axle and sleeve, with the former being simply again welded to the vertical pipes either side *(as shown in Figure 4.5).* The revolving parts of the labyrinth seals would be first pre-welded to the two side of the stainless-steel hopper, while the fixed parts of the seals were pre-welded to each end of the new axle/supply pipe.

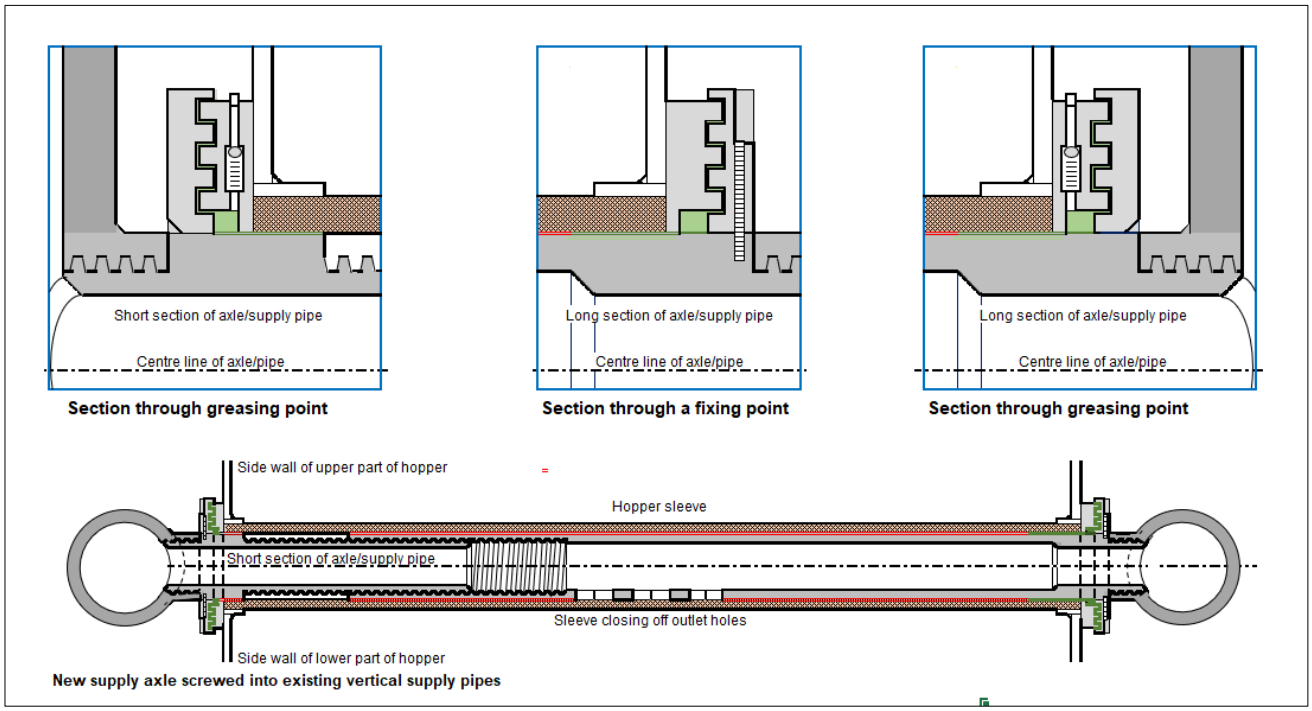
***Figure 4.6*: Horizontal section through axle of large hopper fitted with labyrinth seal**

To still retain the facility to occasionally remove the larger hoppers, the fixed section of the circular labyrinth seal would need to be first unscrewed from the axle to enable the two parts of the axle to be fully screwed together, as in the case of the externally mounted mechanical seals described above. For this reason, the labyrinth seals for the larger hoppers would need to have a narrower width overall, such that once unscrewed it could be slipped to the side to enable the axle to be unscrewed from the two vertical supports *(see Figure 4.6).* However, the consequent shorter labyrinth is likely to make them less effective in stopping leakages.

Unlike the greasing point, the screws securing the fixed section of the labyrinth seal to the axle would not be positioned vertically, but at, say, 5,15 and 25 minutes etc past the hour, where they could be more easily accessed, the screw holes, once exposed, then being similarly used to loosen the axle from the vertical into which it is tightly screwed.

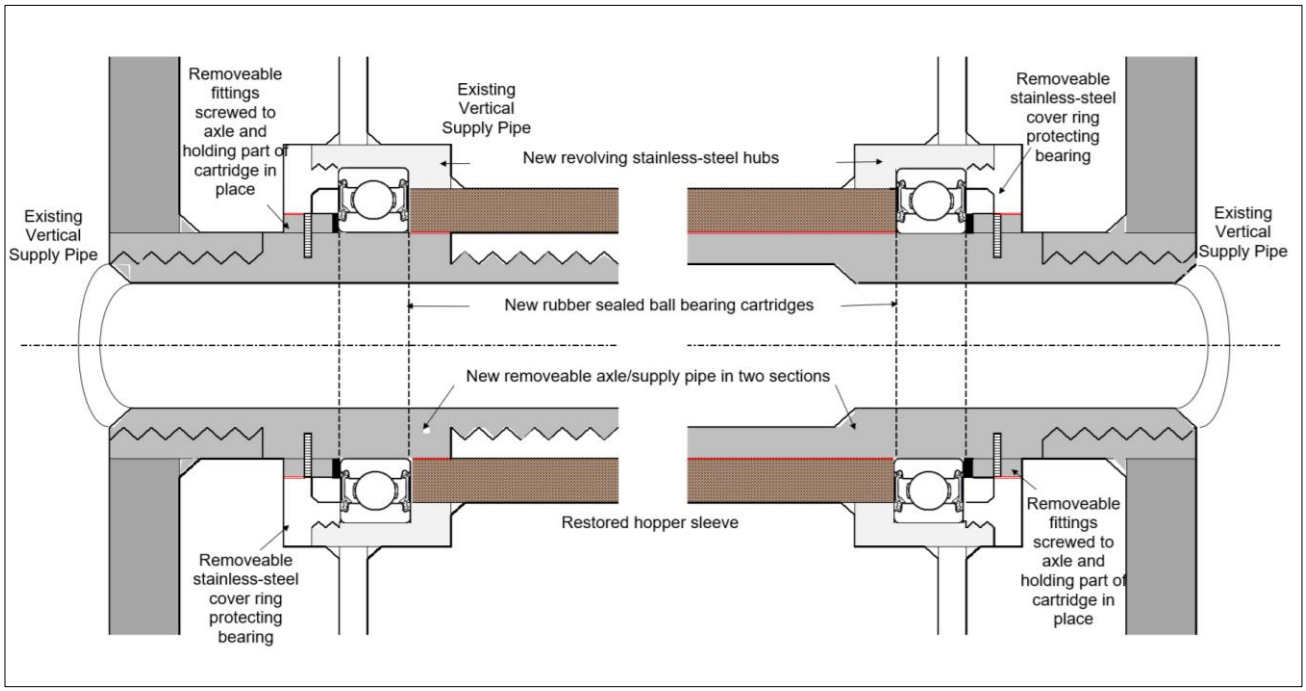
***Figure 4.7*: Possible restoration of the larger hoppers using sealed ball-bearing cartridges.**

As suggested by the IHC report[37], The same design as used for the smaller hoppers for securing the sealed ball-bearing cartridge to the end of the axle closest to the vertical support could be used for both sides of the larger hoppers *(Figure 4.7).* Here to change the cartridge, the protecting stainless steel cover disc would first need to be unscrewed and slid up against the vertical support to uncover the two half round fittings holding the cartridge to the axle. The latter could then be removed and the screw holes so exposed used to purchase the axle to loosen each end from the verticals. The two ends of the axle could then be screwed together and the axle removed from the sleeve, after which the old cartridges could be prised out of the new hubs and new ones pressed in.

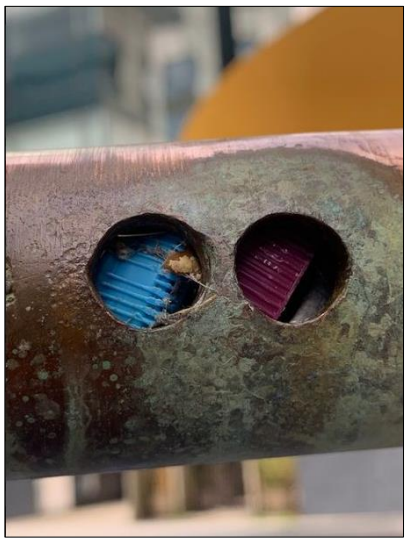
Figure 6.3: **Blocked holes in larger hopper**

Figure 6.4**: Smaller axle blocked**

Figure 6.5: **Broken guard**

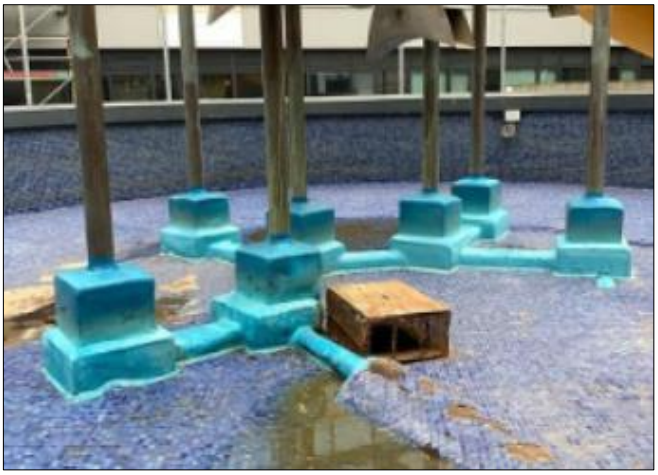
A main cast-iron[65] distribution pipe runs between the pump room and the fountain base frame/ manifold located in the centre of the pool. This is exposed for a short distance where it joins the manifold, adjacent to the sump *(Figure 8.1*). (The short blue 'upstand' in front of the base of the far right vertical in *Figure 8.1* is thought not to be a second pipe, but the end of the splayed foot of the steel base fame, shown in *Figure 1.1*). However, the distribution pipe is mainly hidden beneath the pool floor and consequently its condition is unknown. *Figure 8.2* shows the pump guard removed to expose the sump chamber also inset into the base of the pool floor.

Figure 8.1: **Current base frame & distribution pipes** ***Figure 8.2:*** **Pool sump and removed sump guard**

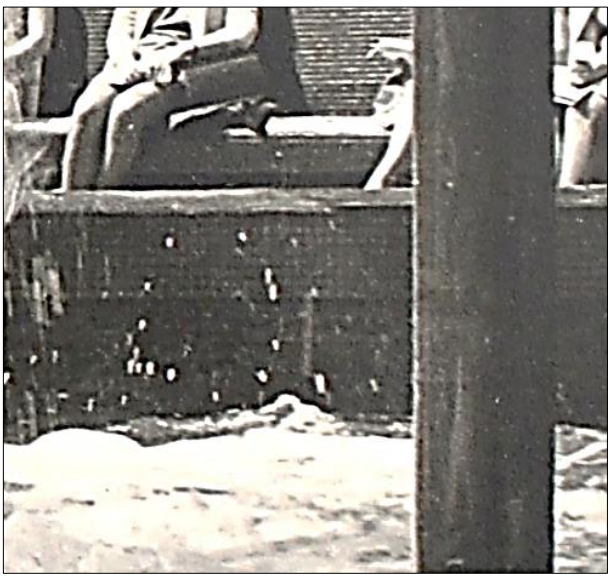
Figure 8.4 indicates that originally shiny black mosaic tiles extended on the inside rim of the receiving pool wall to only around halfway between the top coping and water line below, possibly to avoid damage to the tiling by the cascades and consequent wave effects. As there are no known early photographs of the empty pool after the fountain was completed in 1967, the original finish of the floor and lower part of the inner wall of the pool has not been determined. However, given that the floor of pool was not intended to be seen below the original 16 to 17 inch depth or water and the waves and white water generated on the surface, it is thought that it was probably just painted with a waterproof black paint.

***Figure 8.4*: Original inner wall of pool in 1967**

As a significant area of the mosaic tiling still appears sound, particularly around the top of the pool wall, and the floor should be cushioned in future by a significantly greater pool depth, the cheapest solution would be to restore the pool tiling using matching tiles. However, given the extent of the disrepair, it would probably be more sensible to totally remove all the existing tiling and apply a new floor and wall finish. IHC have further suggested that the waterproof membrane to the whole pool should be restored.[70] Replacing all the existing tiling would also provide the opportunity to restore Richard Huws' stated preference of having the main walls and floors of the fountain complex in a dark colour in order to highlight the white water of the cascades and waves in the pool.[71]

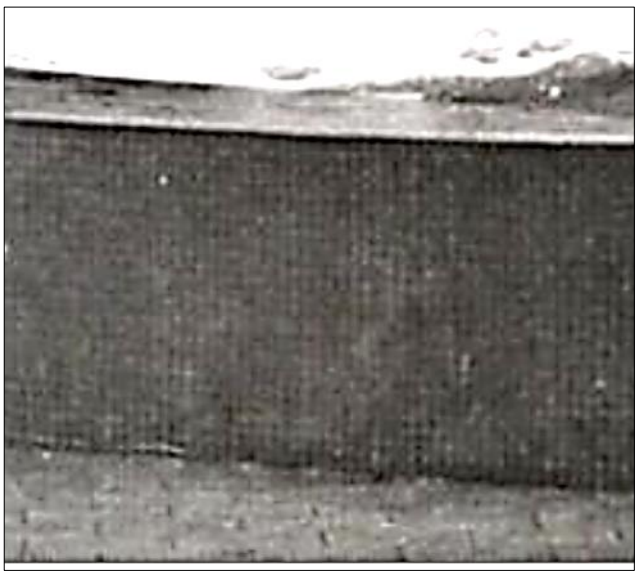
***Figure 8.5:* Original outer wall of pool in 1967**

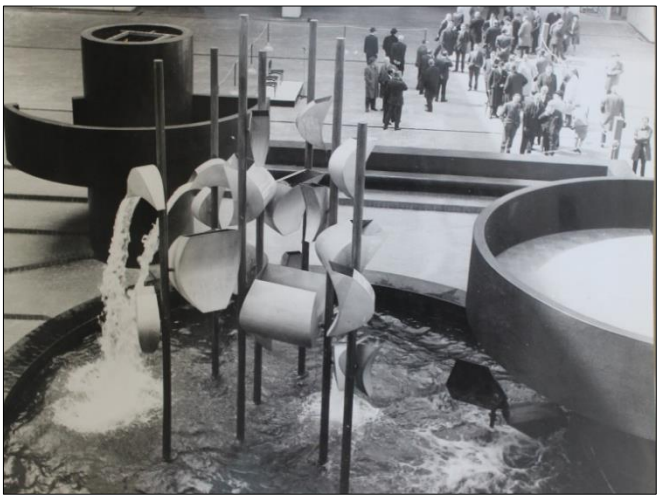
***Figure 8.6*: Narrow pool wall width in May 1967**

With the current rendering on the outer wall of the pool still being in reasonable condition, clearly the least expensive option would be to keep the existing rendering and just repaint the wall. However, if the structural survey shows that the increased weight of the deeper pool is problematic, one option would be to first reduce the load on the supporting structure by reducing the width of the pool wall back to its original narrower width.

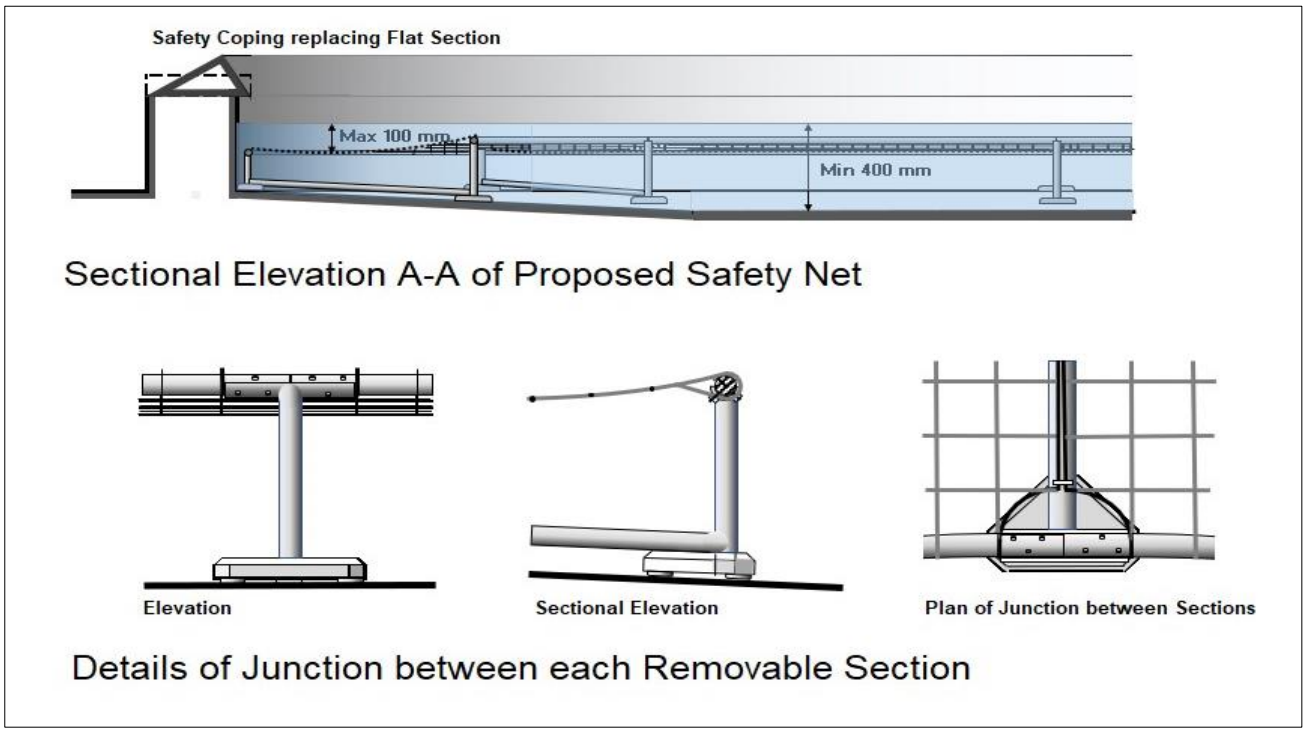
Figure 9.2: **Sectional elevation of suggested safety measures**

Depending on the requirements of Liverpool City Council, raising the water depth in the receiving pool may also require new health and safety measures. As shown in *Figures 9.2* below, this could involve:

a) Replacing the current flat coping on the pool wall with a profiled coping to discourage children sitting, standing on or climbing over it; or
b) Installing a free-standing underwater safety net around the edge of the pool designed to prevent children falling into the deeper water; or
c) Instead of (b), install a semi-rigid underwater GRP shelf around the edge of the pool, as suggested by the IHC restoration report.[79]
d) Both replacing the coping and installing an underwater safety net or a GRP shelf around the edge of pool.

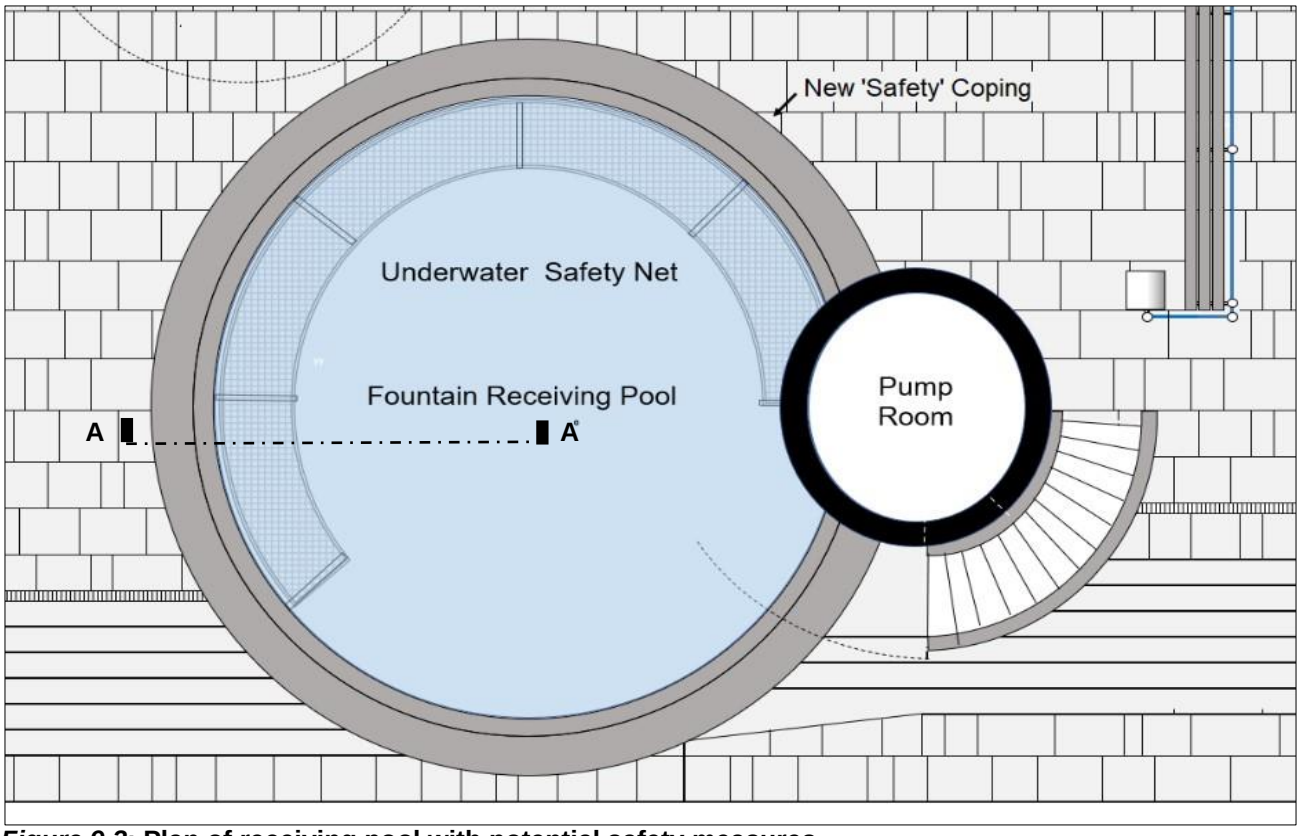
Figure 9.3**: Plan of receiving pool with potential safety measures**

Without compromising on the robustness and rigidity of any safety measures it is the intention that any such measures should be designed and manufactured such that they are as light as possible, so as not to significantly add to the weight on the supporting structure below. In addition to being light, any safety measure in the actual pool would not need to be installed around the whole of the rim as the external pool wall is much higher above the pavement and lower steps on the side closest to Drury Lane *(Figure 9.3)*

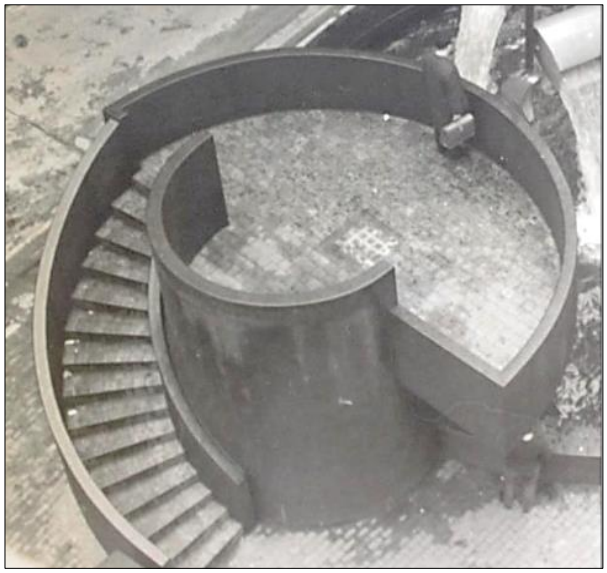
***Figure 10.3*: Larger viewing platform in 1967 and brindle red flooring**

The cheapest solution to restoring the remaining floor finish, would be to simply remove the old finish and apply new asphalt over the floor. However, the current necessity to replace the floor finish provides the opportunity to re-instate the original 1960s finish which was tiled *(as shown in Figure 10.3).* The tiles used were of a red brindle colour and matched the brick tiles used over the whole of the piazza and original shallow steps prior to the wholesale re-landscaping of the piazza between 1997 and 2000. As shown in Figure 10.4 some of the original tiling still exists on the steps which lead up from the Strand to the opposite side of the piazza, although the bottom landing below these steps is believed to have been subsequently retiled in a slightly different colour.[86]
