A WATERFALL OF A STRANGE NEW KIND

Restoration Options

for Richard Huws' Listed
Piazza Fountain, Drury Lane, Liverpool

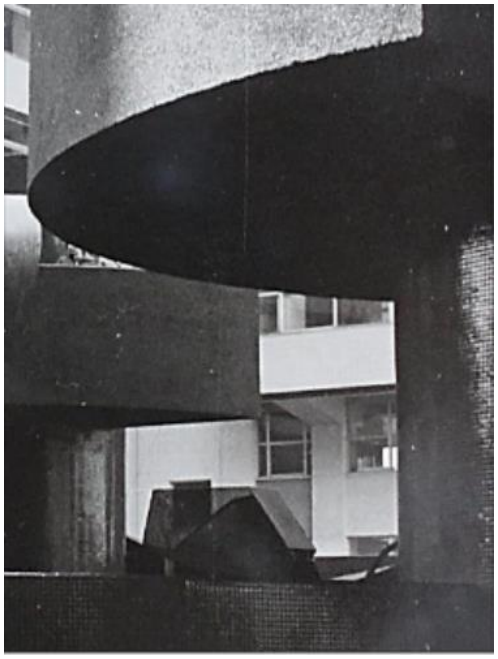
The balustrades of the stairs and upper viewing platforms are rendered and apart from being a different colour are the same as or very similar to the original finish. However, the walls of the cylindrical bases of the two viewing platforms were original finished in black mosaic tiles (*as shown in Figure 10.5).* As shown in *Figure 10.6a*, a small portion of this original mosaic tiling can still be seen between the two spear shafts below the African shield.

***Figure 10.5:* Original surface finishes**

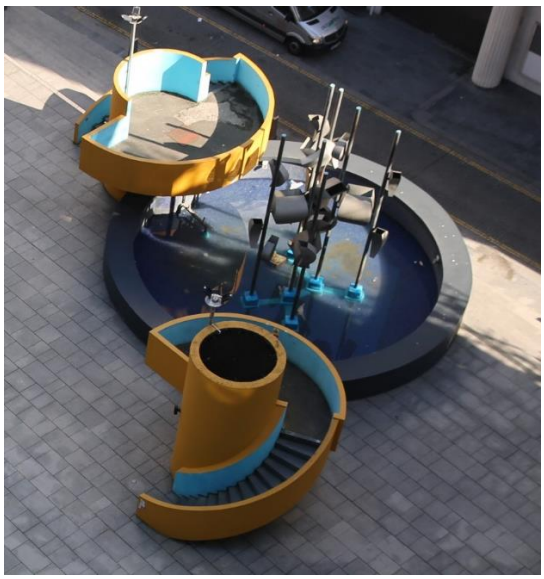
The current colour scheme (option a), which stems from 2018 and was chosen to match the colour scheme of a local restaurant[92], is garish *(Figure 10.8)* and is thought to visually detract from the performance of the actual fountain. The previous colour scheme (option b) was arguably a lot more tasteful, but by painting the whole of the viewing platforms white, it flew in the face of Richard Huws' stated desire to have dark surfaces on the fountain complex to contrast with the white water of the cascades[93] *(see Figure 10.9).*

***Figure 10.8*: The current colour scheme**

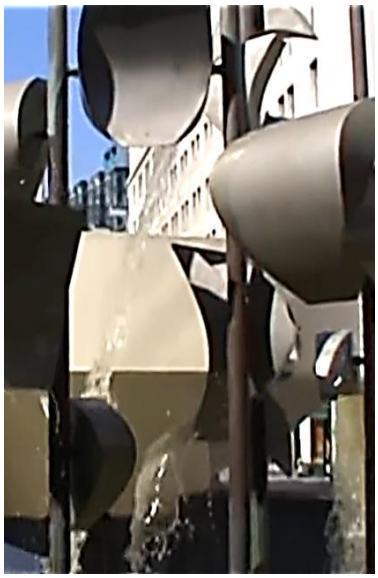
***Figure 10.9*: Same cascade falling past two colour schemes**
